Inspection Report

222 Finest Avenue,
Champaign, IL 61820

Finest Home Inspection

Date: 9/1/2018	Time: 01:00 PM	Report ID: 10251JE2
Property: 222 Finest Avenue, Champaign, IL 61820	Customer: Finest Client	Real Estate Professional: Finest Realtor

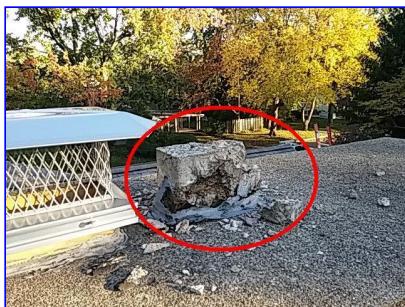
- 1 Chimney at Roof:** It appears that one of the abandoned chimney flues was plugged at some point in the past and now the weatherproofing of the plug has deteriorated. This should be sealed against water intrusion by a qualified masonry contractor. This flue was likely used to vent an older furnace.

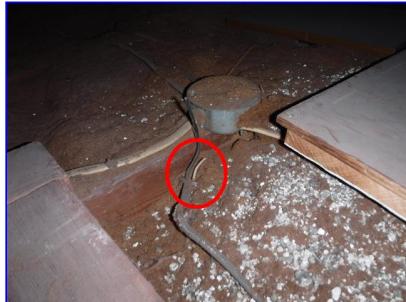
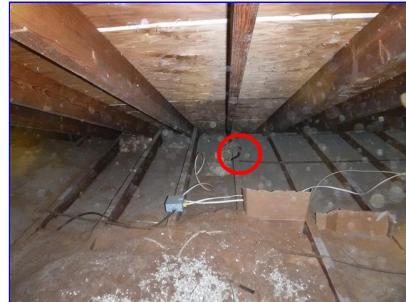
- 2 **Attic Electrical:** Improperly terminated wires were visible in the Attic. Wires should terminate in an approved junction box with a cover installed for safety.

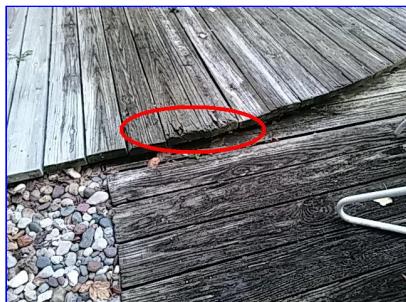
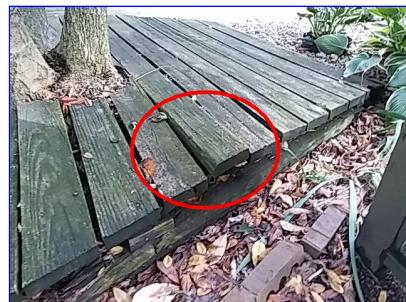
- 4 **Deck:** Deck boards require additional fastening and repairs and should be examined by a qualified contractor for costs and options of all needed repairs.

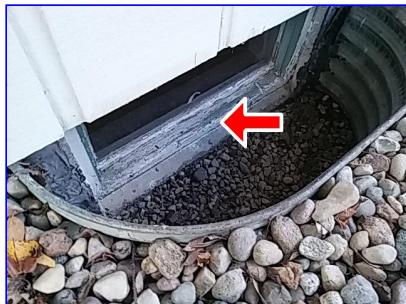
- 5 **Window Exteriors:** The wood frames at the Basement windows require priming, caulking, and painting to protect the condition of the wood.

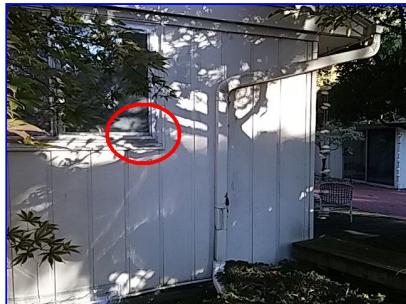
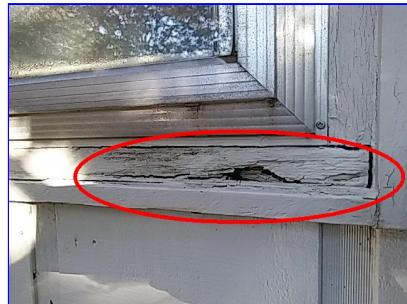
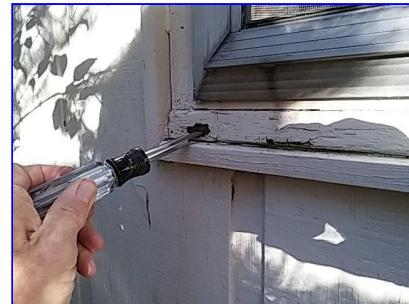
- 6 **Window Exteriors:** The window sills at the West side of the home are weathered and deteriorated and require repair.

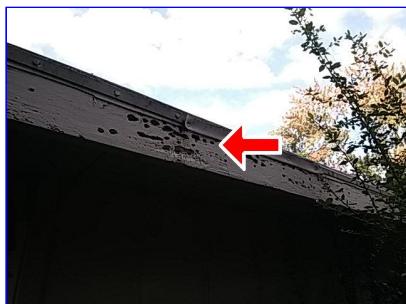
- 7 **Eaves, Soffit, Fascia:** There is some damage to the fascia trim at the South side of the Garage that may be related to past Wood Destroying Organism (WDO) activity. The inspector did not observe any active signs of insects. Repair of the fascia trim will be necessary to prevent damage from moisture intrusion.

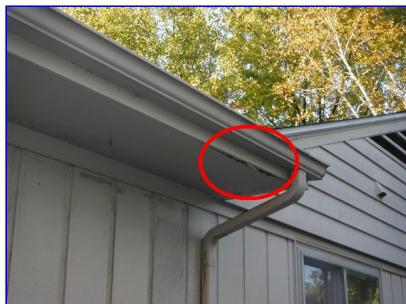
- 8 **Eaves, Soffit, Fascia:** There is a loose area of soffit at the West side of the home that requires additional securing to help prevent pest intrusion.

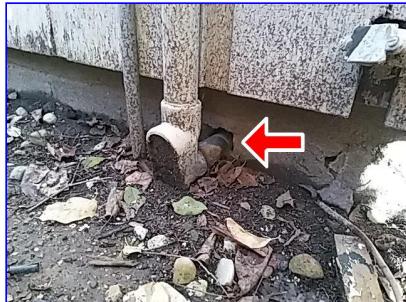
- 9 **Exterior Wall Penetrations:** Exterior wall penetration had gaps that should be sealed to prevent moisture and pest intrusion.

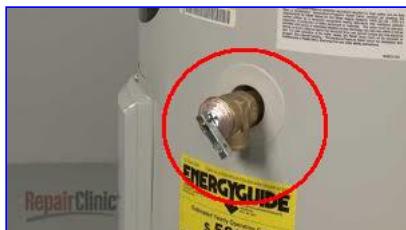
- 11 **Gas Water Heater:** The temperature/pressure relief (TPR) valve had no discharge pipe installed. If the valve were to activate while a person was nearby, that person could be badly burned. A properly-configured TPR discharge pipe should be installed by a qualified plumbing contractor.

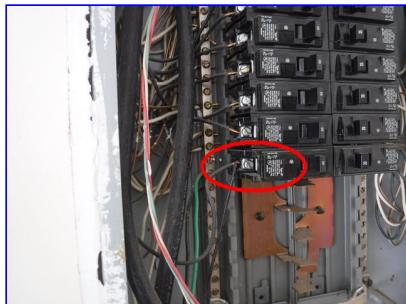
- 12 **Service Panel Wiring:** There is a "double-tapped" circuit in the electric panel. This is a condition where more than one hot wire is connected to a circuit breaker designed for only one wire. This should be corrected by a qualified electrician.

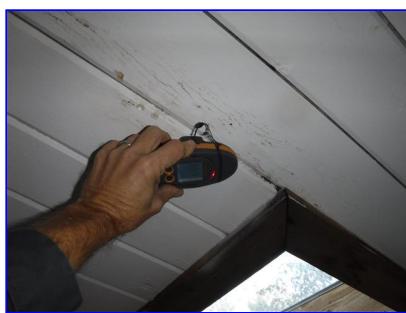
- 14 Windows and Skylights:** The Inspector found active water leaks at the two skylights in the Family Room. The source of the leaks should be identified and corrected by a qualified contractor.

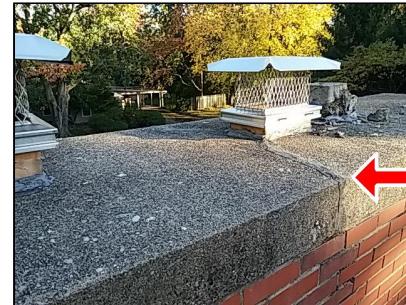
1.4 Chimney at Roof: There are a few cracks in the concrete chimney crown that have had sealant applied in the past and will require re-application of sealant in the future as a maintenance item to prevent water intrusion which can damage the brick.

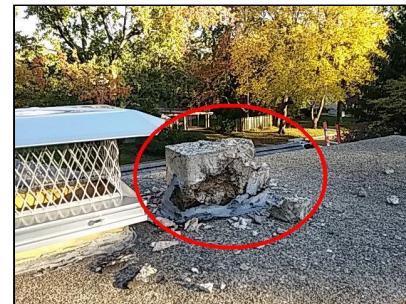
1.4 Chimney at Roof: It appears that one of the abandoned chimney flues was plugged at some point in the past and now the weatherproofing of the plug has deteriorated. This should be sealed against water intrusion by a qualified masonry contractor. This flue was likely used to vent an older furnace.

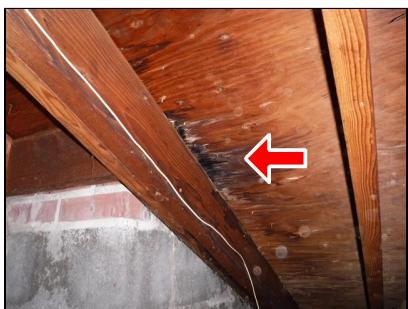
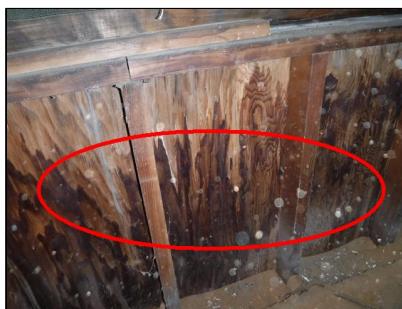
2.2 Roof Sheathing: Roof sheathing had areas of discoloration that appear to be the result of past roof leakage. Although the Roof had experienced recent rain, sheathing did not have elevated moisture levels at the time of the inspection. The source of the leak appeared to have been corrected. The Inspector recommends monitoring for any signs of future leaking.

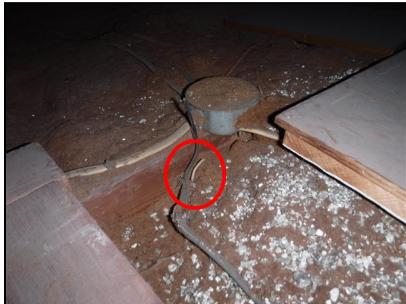
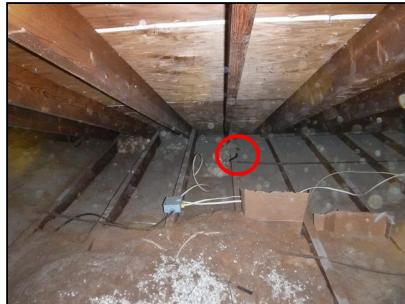
2.4 Attic Electrical: Improperly terminated wires were visible in the Attic. Wires should terminate in an approved junction box with a cover installed for safety.

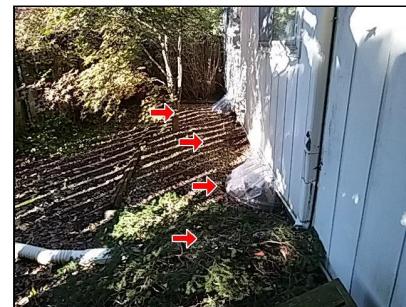
The home had areas of neutral or negative drainage that may route rainfall towards the foundation. Water near the foundation can cause damage to the foundation from soil movement and cause water intrusion into Crawlspace and Basements. The ground should slope away from the home a minimum of $\frac{1}{4}$ -inch per foot for a distance of at least six feet from the foundation. The Inspector recommends that these area be regraded to improve drainage near the foundation.

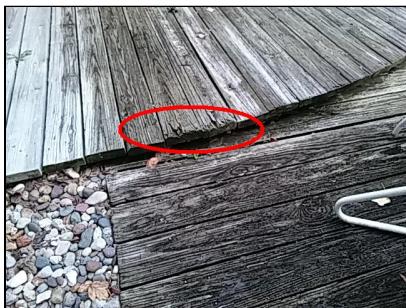
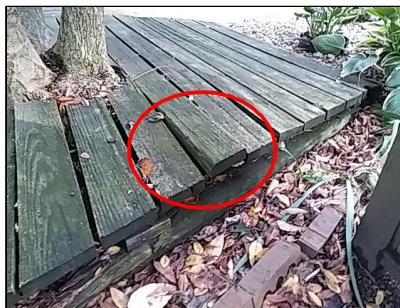
3.5 Deck: Deck boards require additional fastening and repairs and should be examined by a qualified contractor for costs and options of all needed repairs.

3.5 Deck: The Inspector recommends treating the deck with a stain/sealer to increase the longevity of the decking material and to reduce the likelihood of slipping.

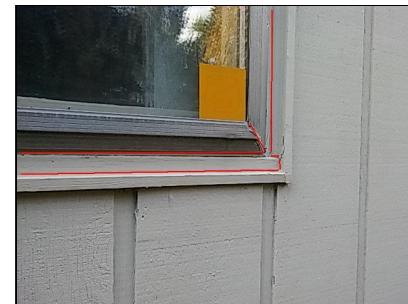
4.1 Window Exteriors: As a maintenance item, the caulk joints between the windows, trim, and siding will require annual checking and re-caulking when needed to help prevent moisture intrusion.

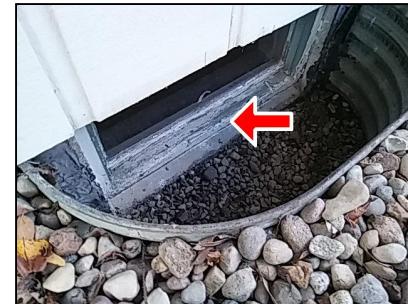
4.1 Window Exteriors: The wood frames at the Basement windows require priming, caulking, and painting to protect the condition of the wood.

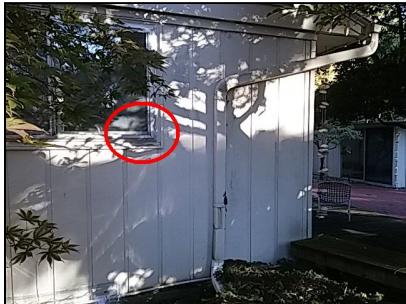
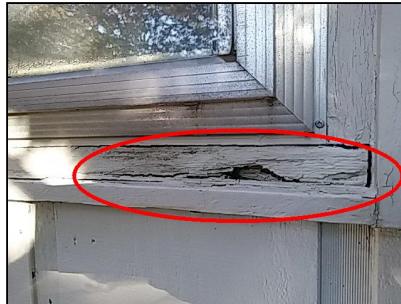
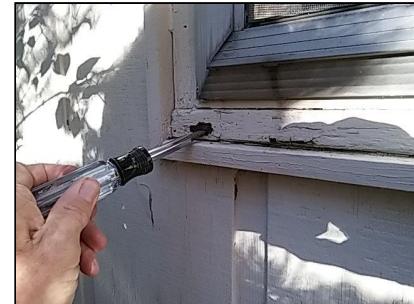
4.1 Window Exteriors: The window sills at the West side of the home are weathered and deteriorated and require repair.

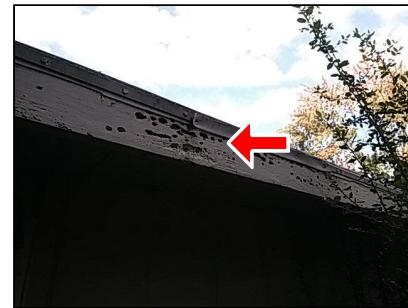
4.3 Eaves, Soffit, Fascia: There is some damage to the fascia trim at the South side of the Garage that may be related to past Wood Destroying Organism (WDO) activity. The inspector did not observe any active signs of insects. Repair of the fascia trim will be necessary to prevent damage from moisture intrusion.

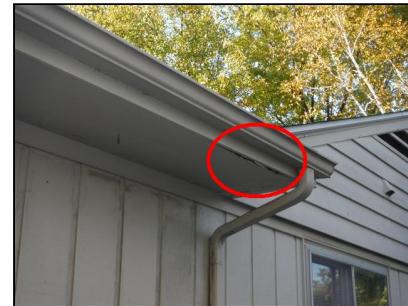
4.3 Eaves, Soffit, Fascia: There is a loose area of soffit at the West side of the home that requires additional securing to help prevent pest intrusion.

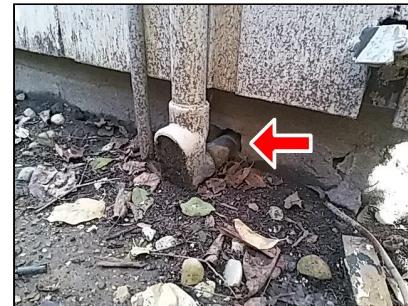
4.4 Exterior Wall Penetrations: Exterior wall penetration had gaps that should be sealed to prevent moisture and pest intrusion.

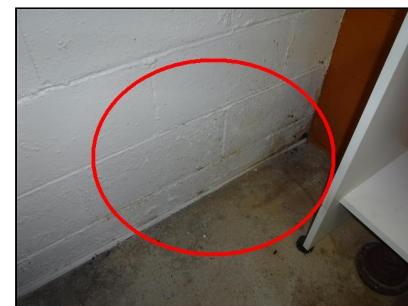
5.2 Foundation: Some signs of past water intrusion were seen in the foundation walls at the Basement. The inspector recommends improving the drainage of rain water around the perimeter of the foundation and monitoring the Basement after heavy rains.

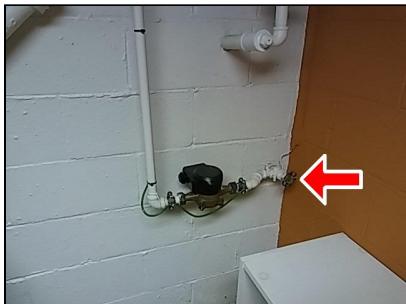
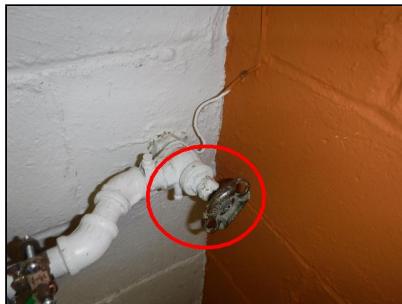
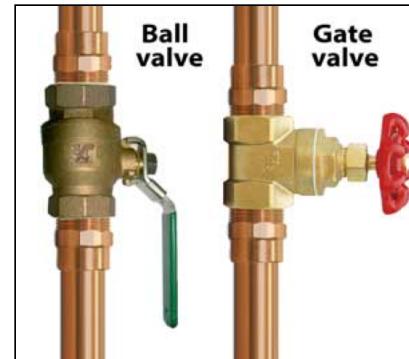
7.0 Water Shut-Off Location: The water meter and water shut-off valve for the home are located in the Northwest corner of the Basement. The older gate valves become less reliable over time. As an improvement, you may consider upgrading to a ball valve in the future.

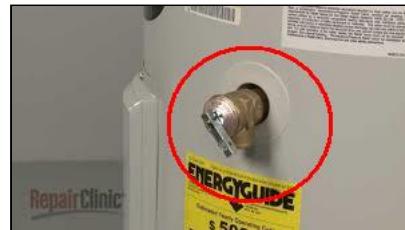
7.6 Gas Water Heater: The temperature/pressure relief (TPR) valve had no discharge pipe installed. If the valve were to activate while a person was nearby, that person could be badly burned. A properly-configured TPR discharge pipe should be installed by a qualified plumbing contractor.

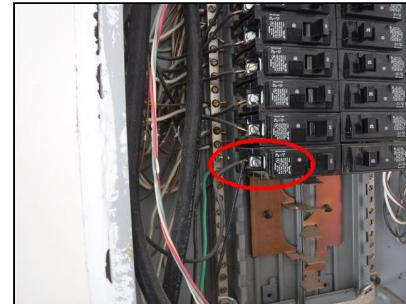
8.4 Service Panel Wiring: There is a "double-tapped" circuit in the electric panel. This is a condition where more than one hot wire is connected to a circuit breaker designed for only one wire. This should be corrected by a qualified electrician.

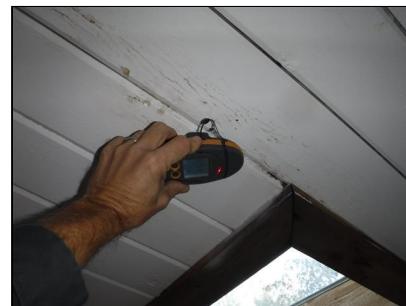
11.1 Windows and Skylights:

The Inspector found active water leaks at the two skylights in the Family Room. The source of the leaks should be identified and corrected by a qualified contractor.

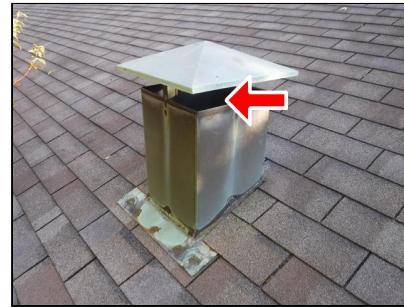
13.5 Range and Range Hood:

The inspector recommends installing a hardware cloth barrier around the opening in the kitchen exhaust hood on the roof to prevent pest intrusion.

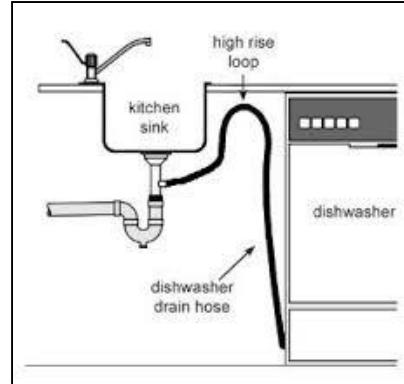
13.7 Dishwasher:

The dishwasher drain line needs to be raised as close as possible to the underside of the countertop and secured to prevent wastewater from flowing backward from the sink drain into the dishwasher.
