Inspection Report

222 Finest Avenue,
Champaign, IL 61820

Finest Home Inspection

Date: 9/1/2018	Time: 01:00 PM	Report ID: 10251JE2
Property: 222 Finest Avenue, Champaign, IL 61820	Customer: Finest Client	Real Estate Professional: Finest Realtor

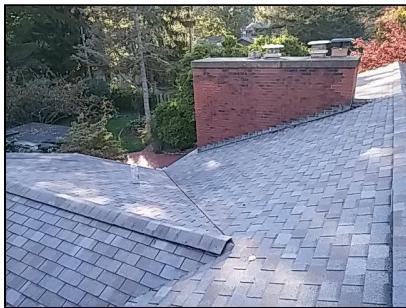
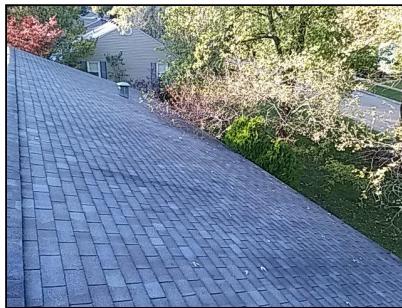
1.0 Roof Structure Exterior: Views from the roof

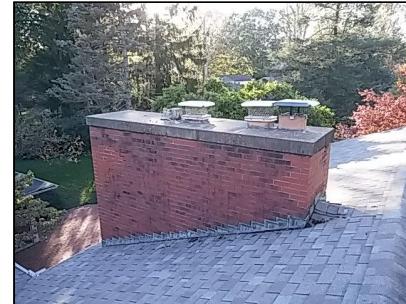
1.4 Chimney at Roof: View of the chimney.

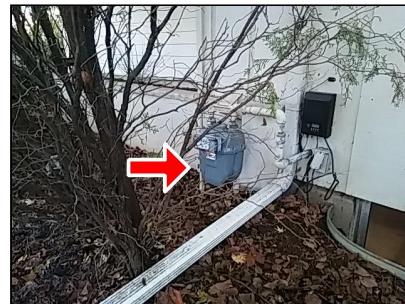
7.4 Main Fuel Shut-Off

Location: The natural gas meter and gas shut off valve are located at the North side of the house. The gas is turned off by rotating the valve 1/4 turn until the lock-holes align.

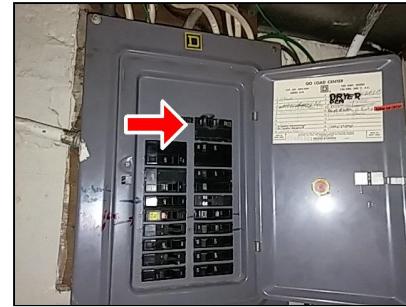
8.2 Service Panel (Locating of Disconnect): The electric service panel and 100 AMP disconnect breaker are located in the Basement closet.
